Repairing Failures Between Block and Mat

THE Foundation Report

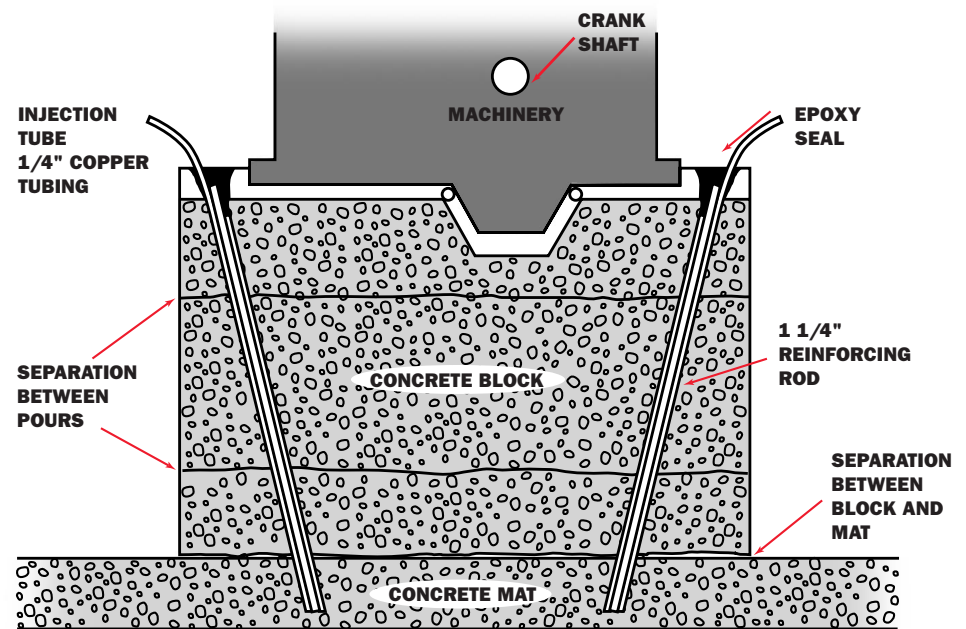
Figure 1:

A method of repairing compressor foundations when the block has separated from the mat.

Operating under these conditions will ultimately result in foundation cracking, separation between the block and mat, or both types of failure.

Figure 1 illustrates a method of repairing separation between the block and mat. Vertical, or near vertical, holes are drilled through the foundation and into the mat. These holes are usually placed in the foundation around the outer periphery of the equipment. Next, rebar is placed in the holes along with an injection tube, and the entrance of the hole is sealed with an epoxy material. After the seal cures, the annular space around the rebar is pressure-filled with an epoxy liquid, and any cracks that the holes cross are then pressure-grouted from the inside out as pressure builds.

The curing of the injected epoxy completes the foundation repair.
