Proper and Improper Grouting of Skid Mounted Equipment

THE Foundation[®] Report

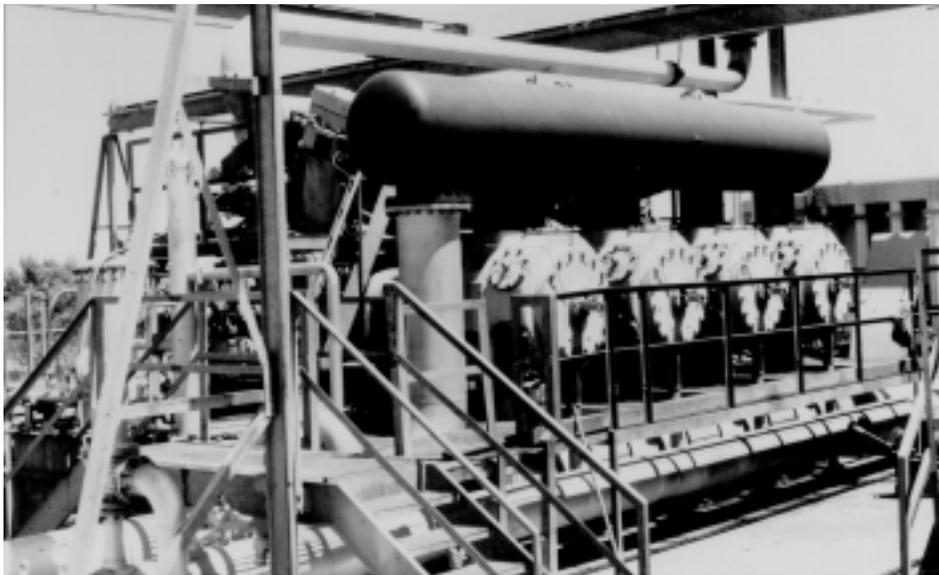
Fig. 1: A typical skid mounted integral gas engine compressor complete with accessories, controls and instrumentation.

A typical skid mounted integral gas engine compressor is shown in Figure 1. When proper techniques are carried out during the original installation, the grout should contact the entire lower surfaces of

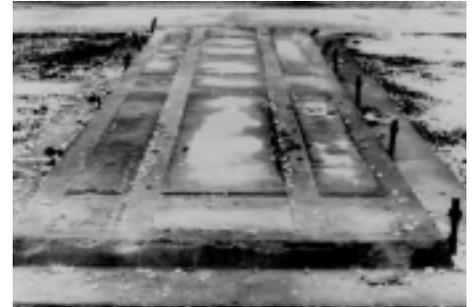
Fig. 2: This illustrates proper skid grouting.

Figure 2 is a photograph of foundation pad where a skid has been removed leaving the cement grout intact. This photograph illustrates proper cement grouting. Note the impression left in the grout by the lower flange of the longitudinal and transverse “T”

beams. Virtually 100% grout contact was obtained on these load bearing surfaces.

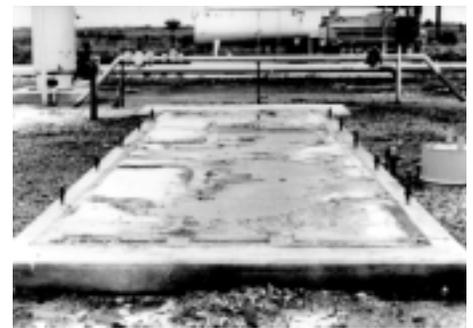
Fig. 3: Poor grout placement on a similar installation.

Figure 3 is an example of poor grout placement. Note the lack of support in the center where most of the machinery weight is concentrated. Long, unsupported spans are an invitation to resonant vibration problems and to progressive sagging of the beams with age. Progressive sagging will eventually cause continual misalignment problems. Further, the anchor bolts on the compressor side of the crankcase are attached to one of the internal longitudinal beams. When the equipment is at rest, there may be perfect alignment; however, when the equipment is running, the beam may be flexing much the same as a suspension bridge. If this is true, fatigue of the crankshaft and bearing damage may result.

The obvious solution to this defect is to grout in the unsupported sections. Since cement grout will not bond well to itself or concrete, any regrouting should be carried out
