Proper Design Concepts of Original Anchor Bolt Installations

THE Foundation Report

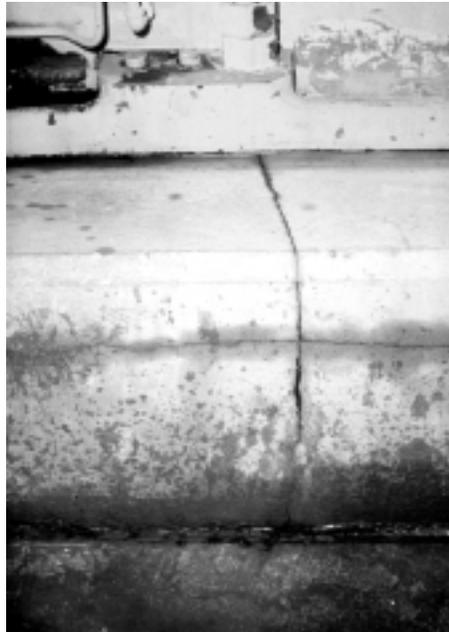
Fig. 2: A photograph showing foundation cracks at an anchor bolt. This crack is in a plane perpendicular to the crankshaft.

Figure 2 is a photograph illustrating the

cracking of a foundation at an anchor bolt with the plane of the crack perpendicular to the crankshaft. After startup, the machine may grow as much as 0.25" from thermal expansion. This crack was caused by grout being placed in the anchor bolt sleeve during original construction thereby restricting movement of the bolt.

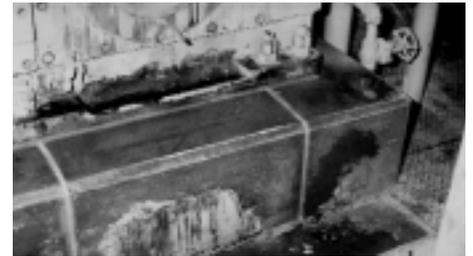
Fig. 3: A photograph after regrouting. Note the expansion joint at the anchor bolt and that the outer periphery of the machine base has been sealed with a fillet of silicone rubber.

Figure 3 is a photograph of the foundation

after regrouting. The exposed portion of the anchor bolt was isolated with a tubular closed-cell polyurethane sleeve prior to repouring the epoxy grout. An expansion joint was installed to prevent new cracks from forming. After the grout has cured and the forms have been removed, the expansion joints and the outer periphery of the machine base where the grout contacts the boss are sealed with oil-resistant silicone rubber. The silicone provides a barrier against infiltration of oil and other liquids into the foundation.
