Special Considerations When Using Epoxy Grout on Outdoor Installations

ISSUE 1

THE Foundation Report ©

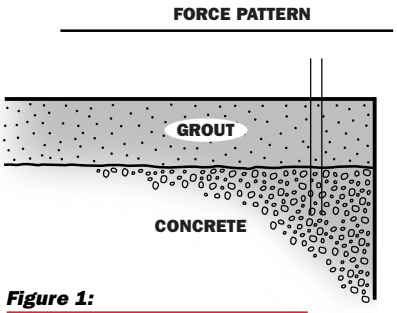
Figure 1:
The system at thermal equilibrium

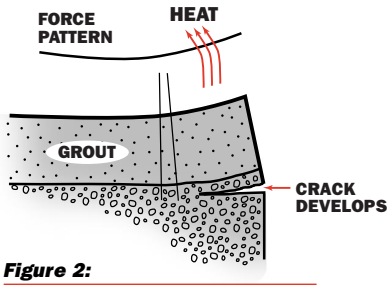
Because epoxy grout and concrete absorb and dissipate heat rather slowly, cyclic temperatures between day and night cause uneven thermal expansion or contraction at various levels in the foundation. Uneven thermal expansion produces stresses that can exceed the strength of the weak link in the system. The weak link is usually the tensile strength of the concrete. In **Figure 1** the system is at thermal equilibrium and there are no stresses. In **Figure 2,** during the cooling cycle, the top portion of the grout contracts more than the lower surface.

Figure 2:
The system during the cooling cycle

This gradient in temperature causes stresses that promote the curling of the epoxy at the corners. Because the tensile strength of the concrete is much lower than that of the epoxy, the concrete fails by cracking at the corner where the stress is the greatest. Typically the following day, as illustrated in **Figure 3,** during the heating cycle, the stress pattern reverses and any cracks created during cooling close up. The cycle is repeated as time progresses, and

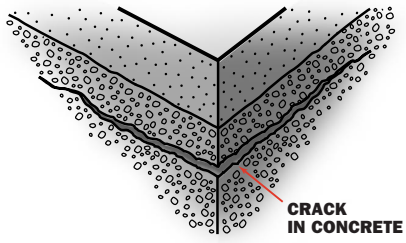
each day the crack proceeds a little more until it eventually works its way to the edge of the equipment. Such cracks seldom cause a failure of the grout under the equipment. They do, however, provide a path for oil penetration to the concrete below. The thicker the grout, the greater the tendency for such cracks to develop. These cracks, which are the same as in the sketch in **Figure 4** illustrating an oblique view, can be virtually eliminated by utilizing one of the design techniques illustrated in **Figures 5, 6,and 7.**

Figure 4:
An oblique view to corner cracking in foundation
