Preparation of Concrete Surfaces Prior to Grouting

THE Foundation Report

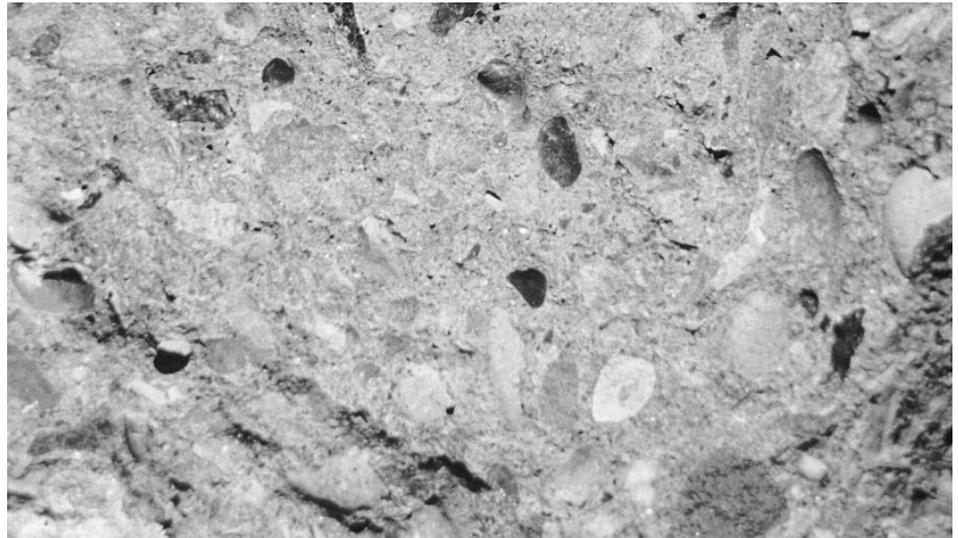
The only **good method** of preparing a concrete surface prior to grouting is to chip away the surface with a chipping gun to expose coarse aggregate. This means at least a minimum of 1/2" to 1" of the surface must be removed. **Poor methods** of surface preparation include raking the surface of concrete prior to curing, intermittent pecking of the surface with a chipping gun, sandblasting the surface after the concrete has cured, and roughening the surface with a bushing tool (a spiked potato masher). Distinguishing between good and poor concrete surface preparation requires an understanding of bleeding of fresh concrete pours and mechanisms involving hydration of cement. Bleeding of freshly placed concrete is a form of separation where water in the mix tends to rise to the surface. In the course of bleeding, some of the solid ingredients classify near the surface. Classifying of concrete ingredients is a form of sedimentation.

Figure 1:
Proper chipping of the surface of concrete prior to grouting
