Complete Anchor Bolt Replacement

Issue 6

THE Foundation Report ©

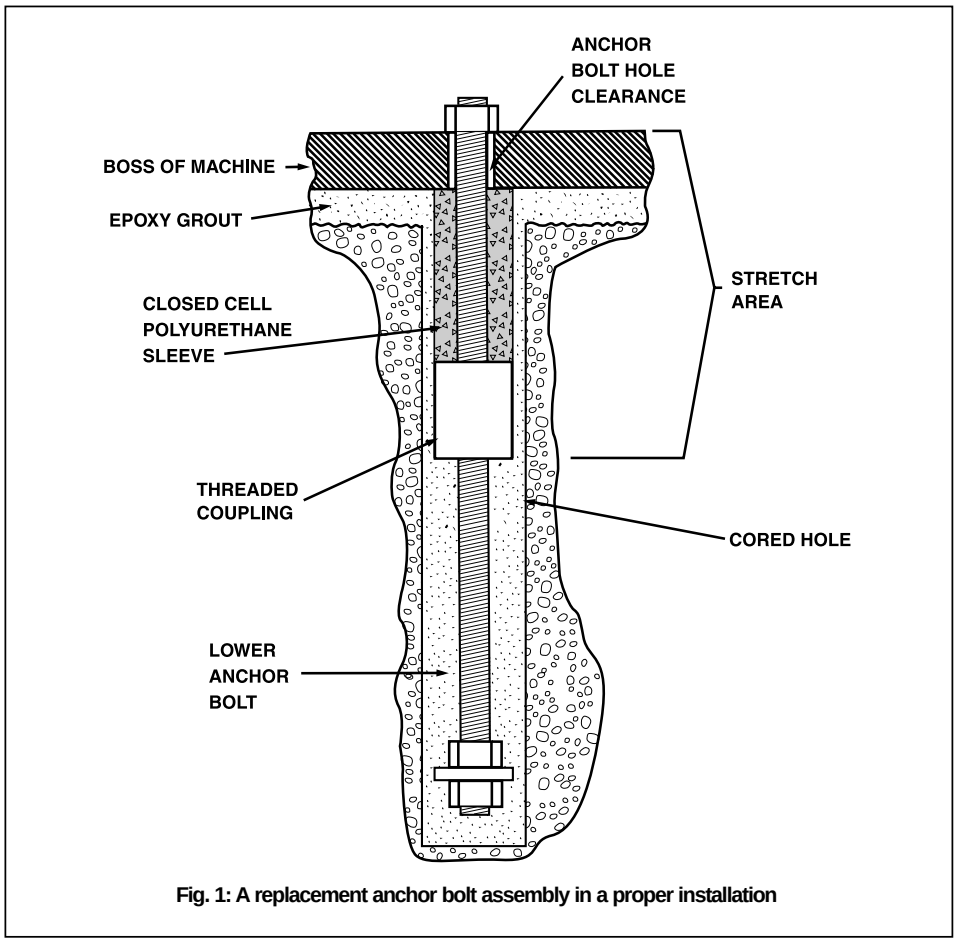
When anchor bolt failure is such that complete replacement is necessary, it can be accomplished using techniques consistent with the sketch shown in Figure 1. This sketch is of a typical replacement anchor bolt in an ideal installation. Complete replacement of an anchor bolt is possible without lifting or regrouting the machine. This is accomplished by drilling large diameter vertical holes, adjacent to the anchor bolt to be replaced and tangent to the boss of the machine. Once the cores have been removed, access is gained to concrete surrounding the anchor bolt. After the surrounding concrete is chipped away, a two-piece and sleeved anchor bolt is installed. After the replacement anchor bolt has been installed, epoxy grout is poured to replace the concrete chipped from around the original bolt and to replace the concrete removed by the coring.

Fig. 1: A replacement anchor bolt assembly in a proper installation
